# HOME INSPECTION REPORT

Wednesday, April 4, 2018

**Report Number:**

1477

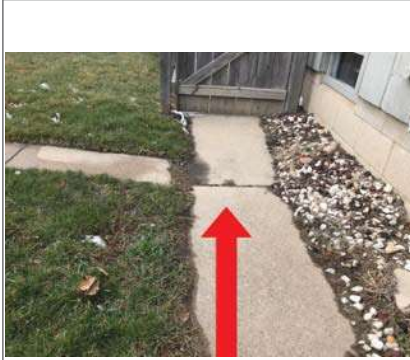
Recommend mud jacking service walk

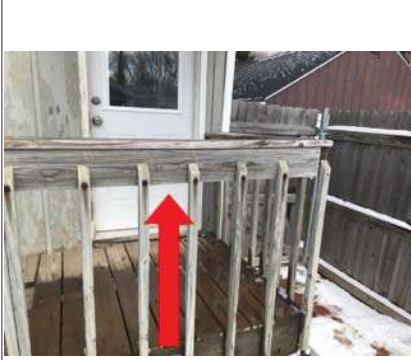
Recommend adding balusters on back deck

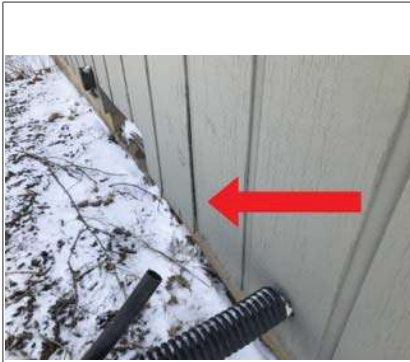
Recommend securing siding

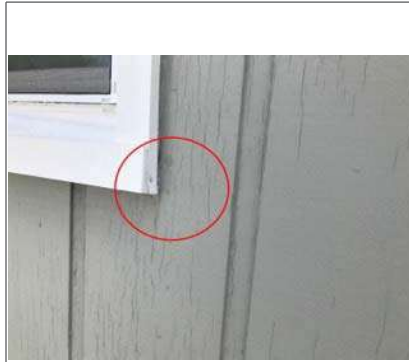
Soft spot in siding

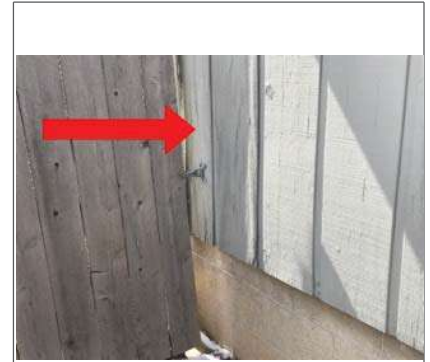
Rotten siding on south east corner

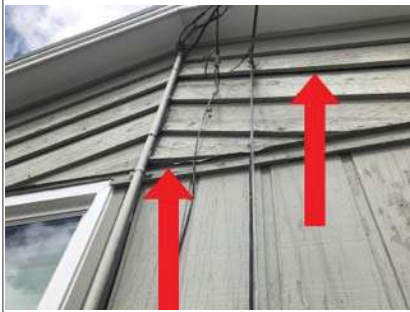
Siding starting to cup.

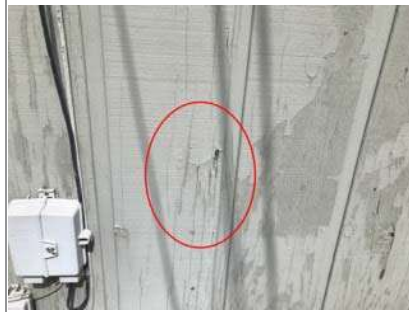
Soft spot.

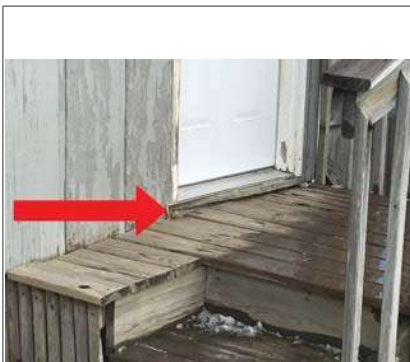
Threshold is rotten

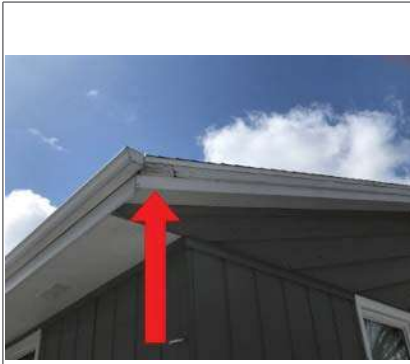
Paint

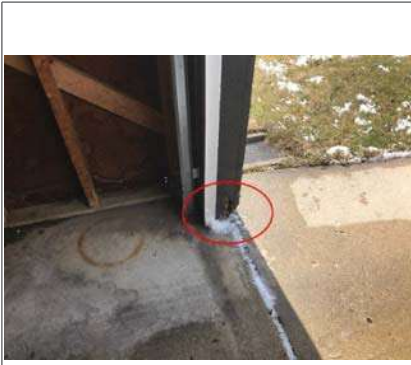
Rotten trim

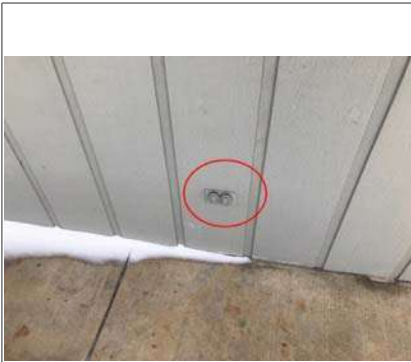
Open ground

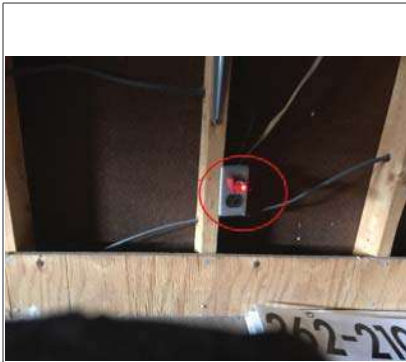
Open ground

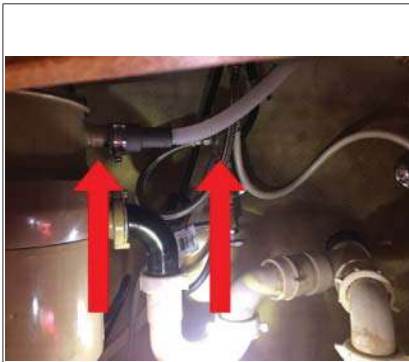
Corroded pipe under sink

Corroded pipe, and dishwasher connected to disposal.  
 Recommend separate drain or air gap.

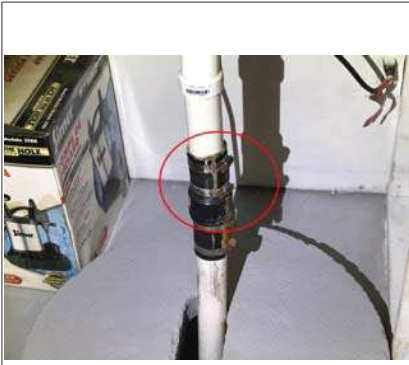
Sump pump check valve is leaking

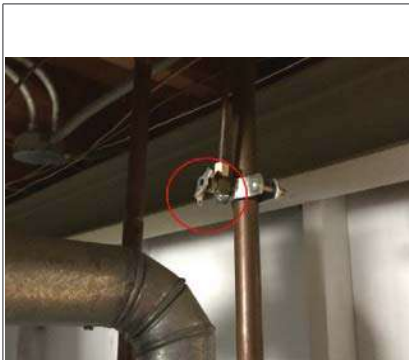
Leak on water heater line

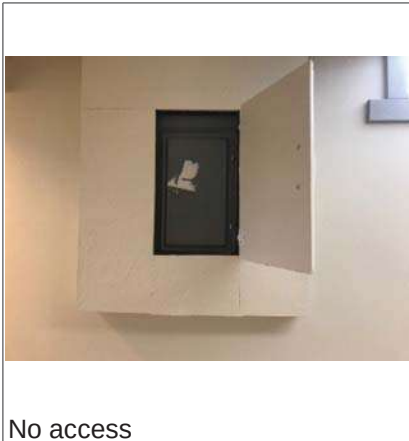
Refrigerator was not on.  
electrical panel has no access

No access
